Sep 14th, 2025

5855 Ludwig Rd, Oxford, MI, 48371

# Home Inspection Report

Tom Witek / To The Rescue Home Inspections LLC

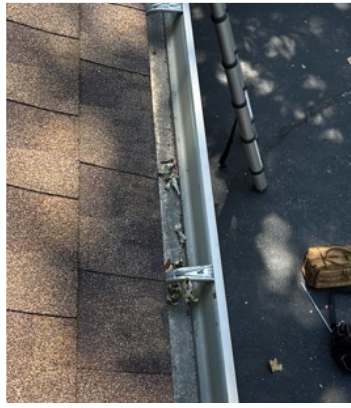
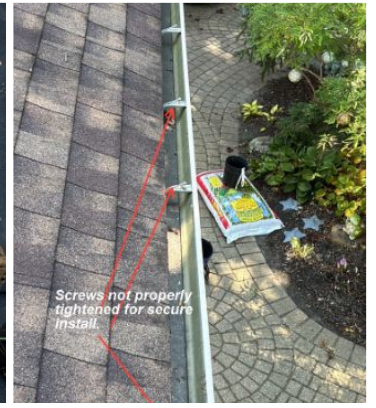
improper install

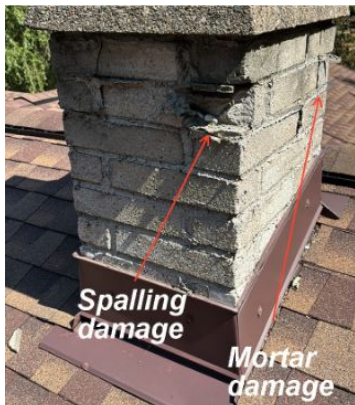
Brick spalling

Brick(s) has broken or popped surface(s)

Recommend that a qualified contractor evaluate and estimate repairs

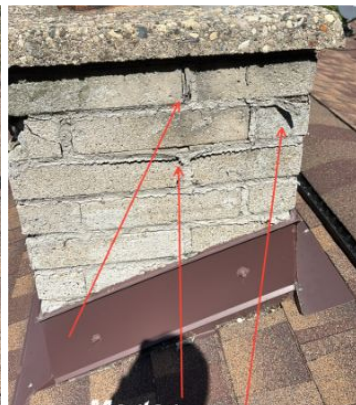
mortar damage

Chimney requires tuck point repair

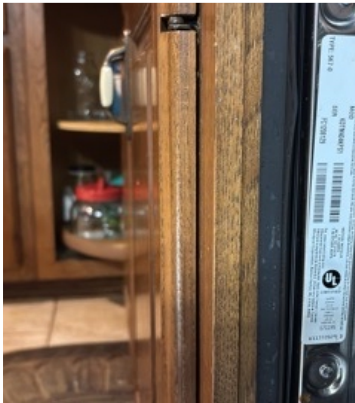
Ran cycle at time of inspection

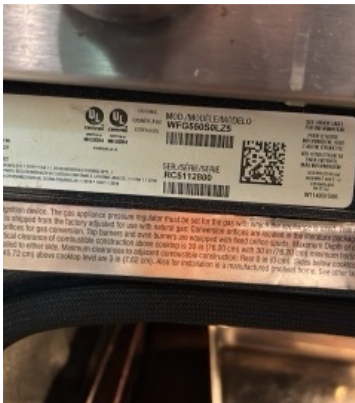
Appeared functional at the time of the inspection

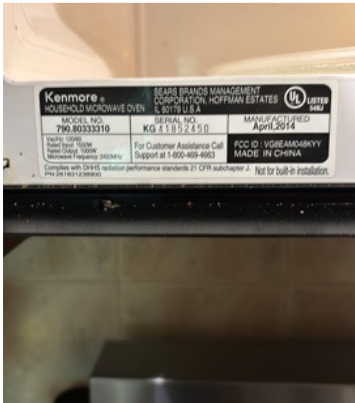
Appeared functional at the time of the inspection
